Zehndorfer
Engineering Consulting

PID-Analyse

14.9.2015

Middle East

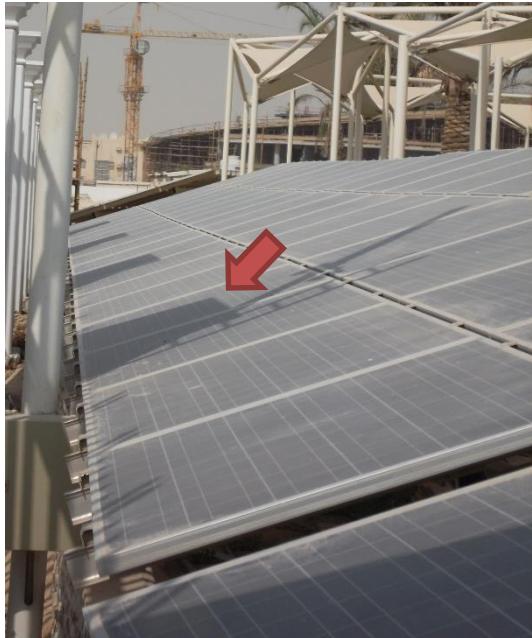
Visual inspection

- No inverter errors
- Cables & plugs no visual damage
- PV cables should be protected from sharp edges
- Grounding present at inverter & mounting structure

- Some permanent shading by fence (can lead to local hotspots over a longer time)
- No visual damage of glass or cells

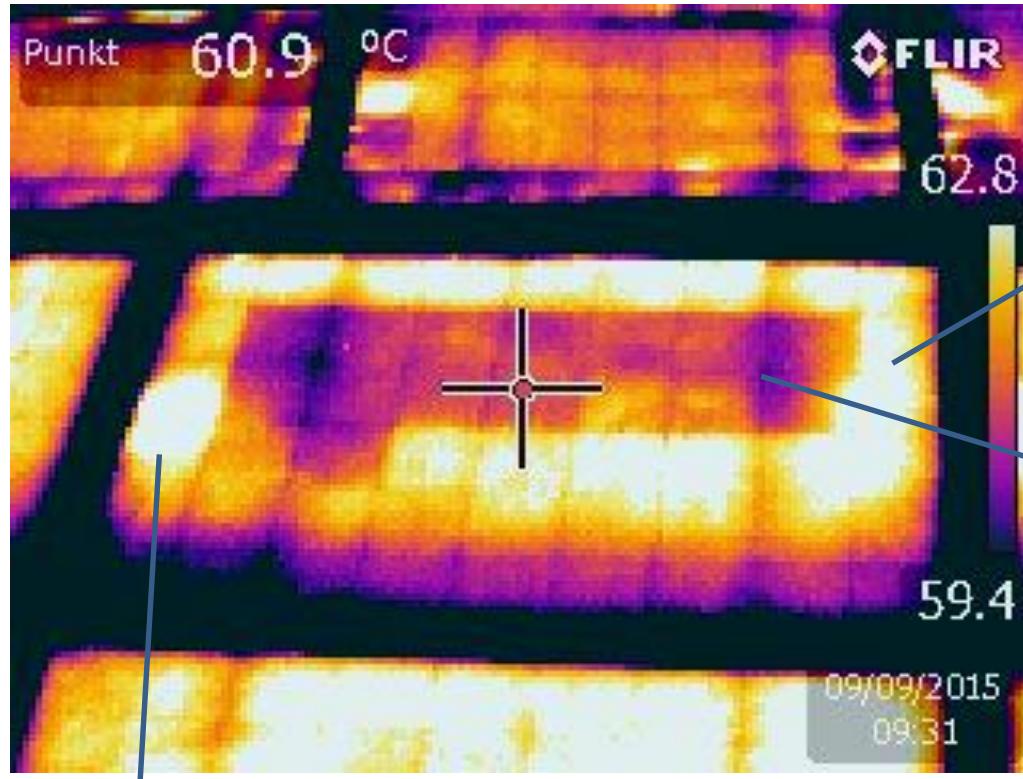
Measurements - Infrared

Junction box (normal)

Hot cells at the edge
(peculiar)

Cooler cells in the middle

Temperature difference approx 3-4K

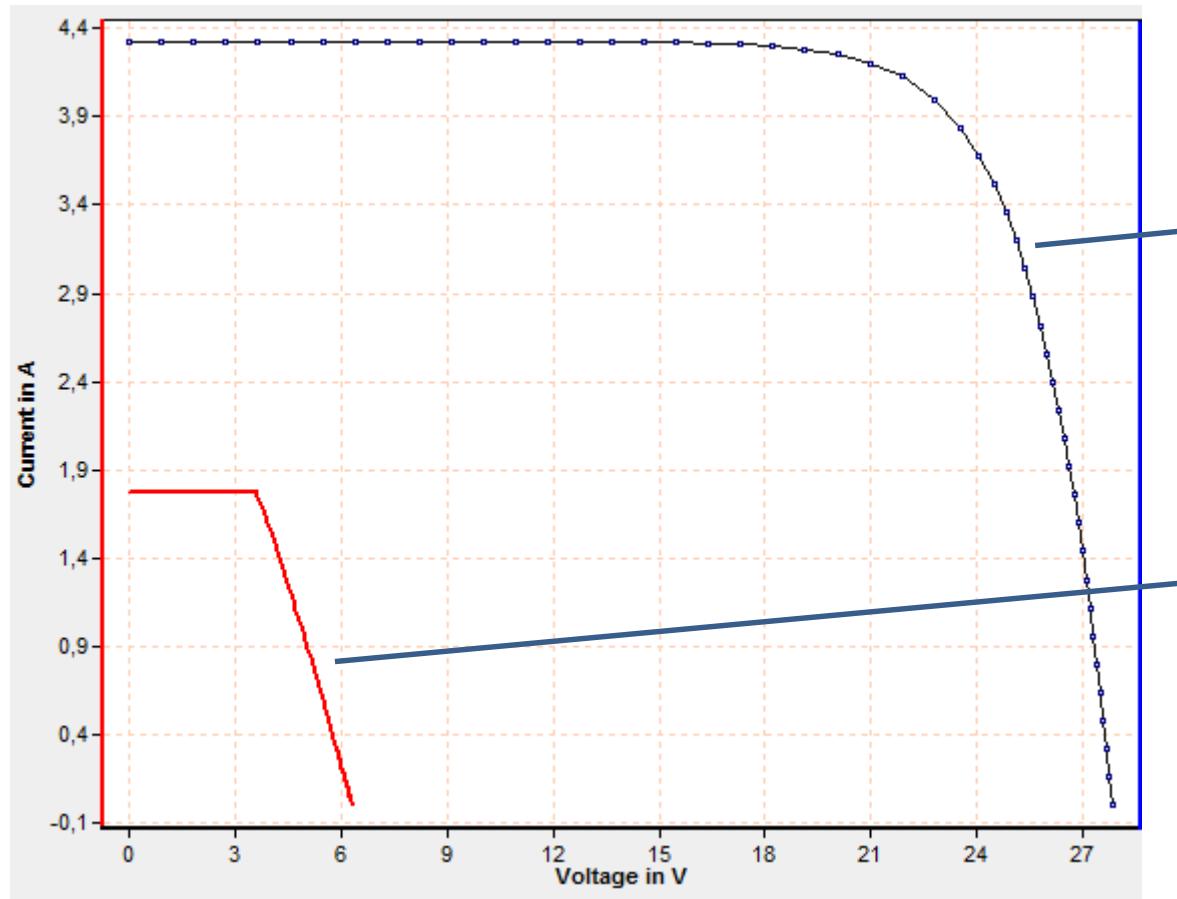
Measurements – IV-curve

Nominal Curve

Measured Curve

- Significant reduction in generated power
- No visual damage
- No inverter errors
- No observable design errors
- No observable faults in execution
- PID (Potential Induces Degradation) on all PV panels

- EL-Analysis of 1 module
- Trial run with SMA Offset-box
